# SITE CLASSIFICATION

Client: Arbor Estates Pty Ltd 24 Jewell Court East Bendigo, Vic 3550

**Date:** 19 August 2015

Project: Lot 23 Brooklands Drive, Canterbury Estate

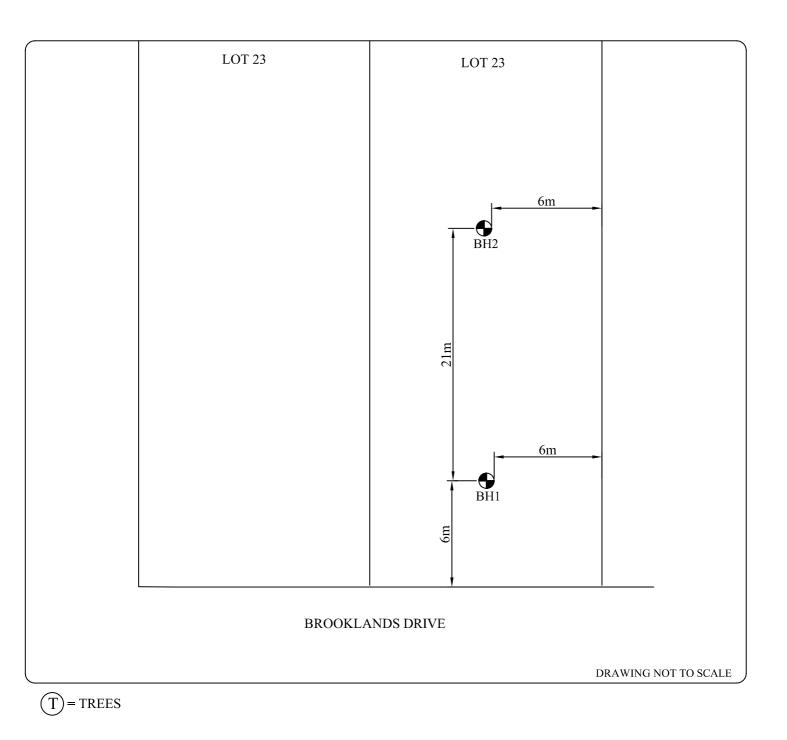
# **Borehole Locations**

The investigation was conducted by a technician on the 30<sup>th</sup> July, 2015 using a vehicle mounted drillrig and drilling 2 boreholes to depths of 1.5 metres within the designated area. The subsequent soil profiles are presented in page 4 and the location of the boreholes are presented on page 5.

Client :	ARBOR ESTATES		Borehole No. :	1 - 2
			Report No. :	15C 0668
			Date Drilled :	30/7/15
Project:	LOT 23 BROOKLANDS DRIVE CANTERBURY ESTATE		Operator:	RC
-			Drilling Method:	A.S
			Page No.:	5 of 5
