# SITE CLASSIFICATION

**Client:** Arbor Estates Pty Ltd  
24 Jewell Court  
East Bendigo, Vic 3550

**Project:** Lot 25 Brooklands Drive, Canterbury Estate

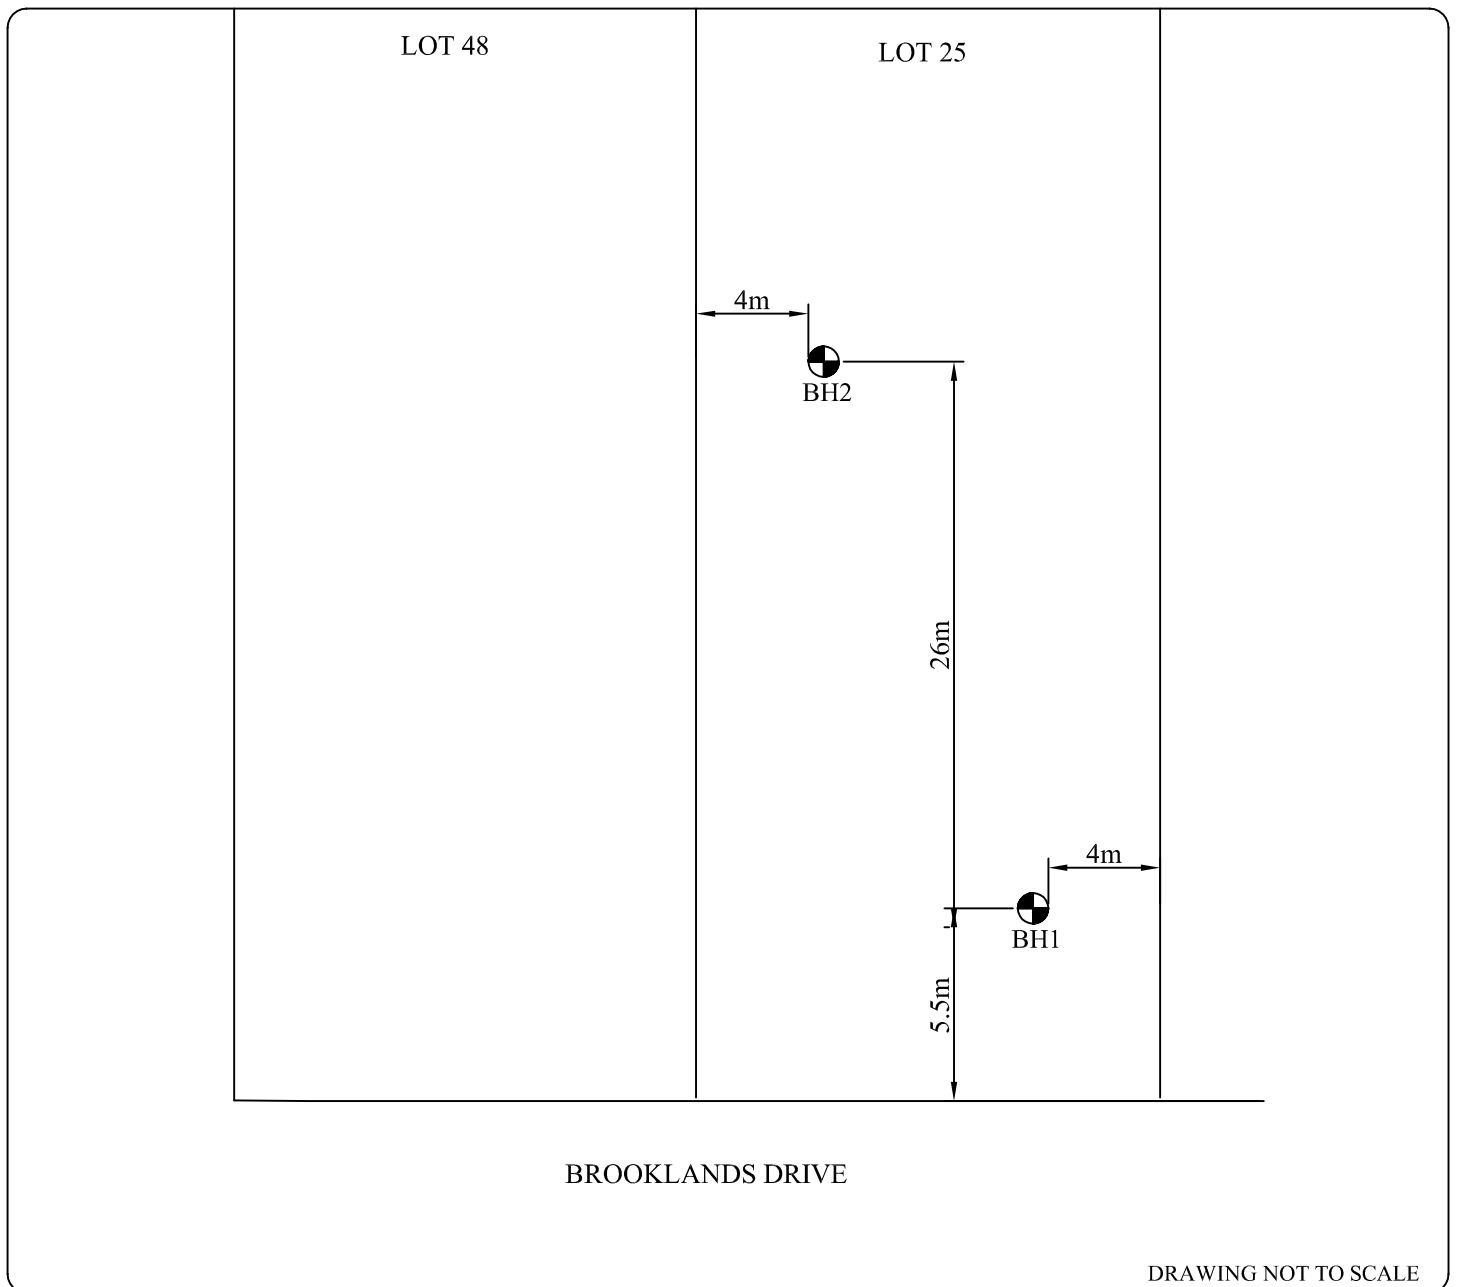
## Borehole Locations

Client :	ARBOR ESTATES
Project:	LOT 25 BROOKLANDS DRIVE CANTERBURY ESTATE

Borehole No. :	1 - 2
Report No. :	15C 0668
Date Drilled :	10/8/15
Operator:	ML
Drilling Method:	A.S
Page No.:	5 of 5

(T) = TREES

The investigation was conducted by a technician on the 10<sup>th</sup> August, 2015 using a vehicle mounted drill-rig and drilling 2 boreholes to depths of 1.5 metres within the designated area. The subsequent soil profiles are presented in page 4 and the location of the boreholes are presented on page 5.
