# SITE CLASSIFICATION

**Client:** Arbor Estates Pty Ltd  
24 Jewell Court  
East Bendigo, Vic 3550

**Date:** 20 August 2015

**Project:** Lot 26 Brooklands Drive, Canterbury Estate

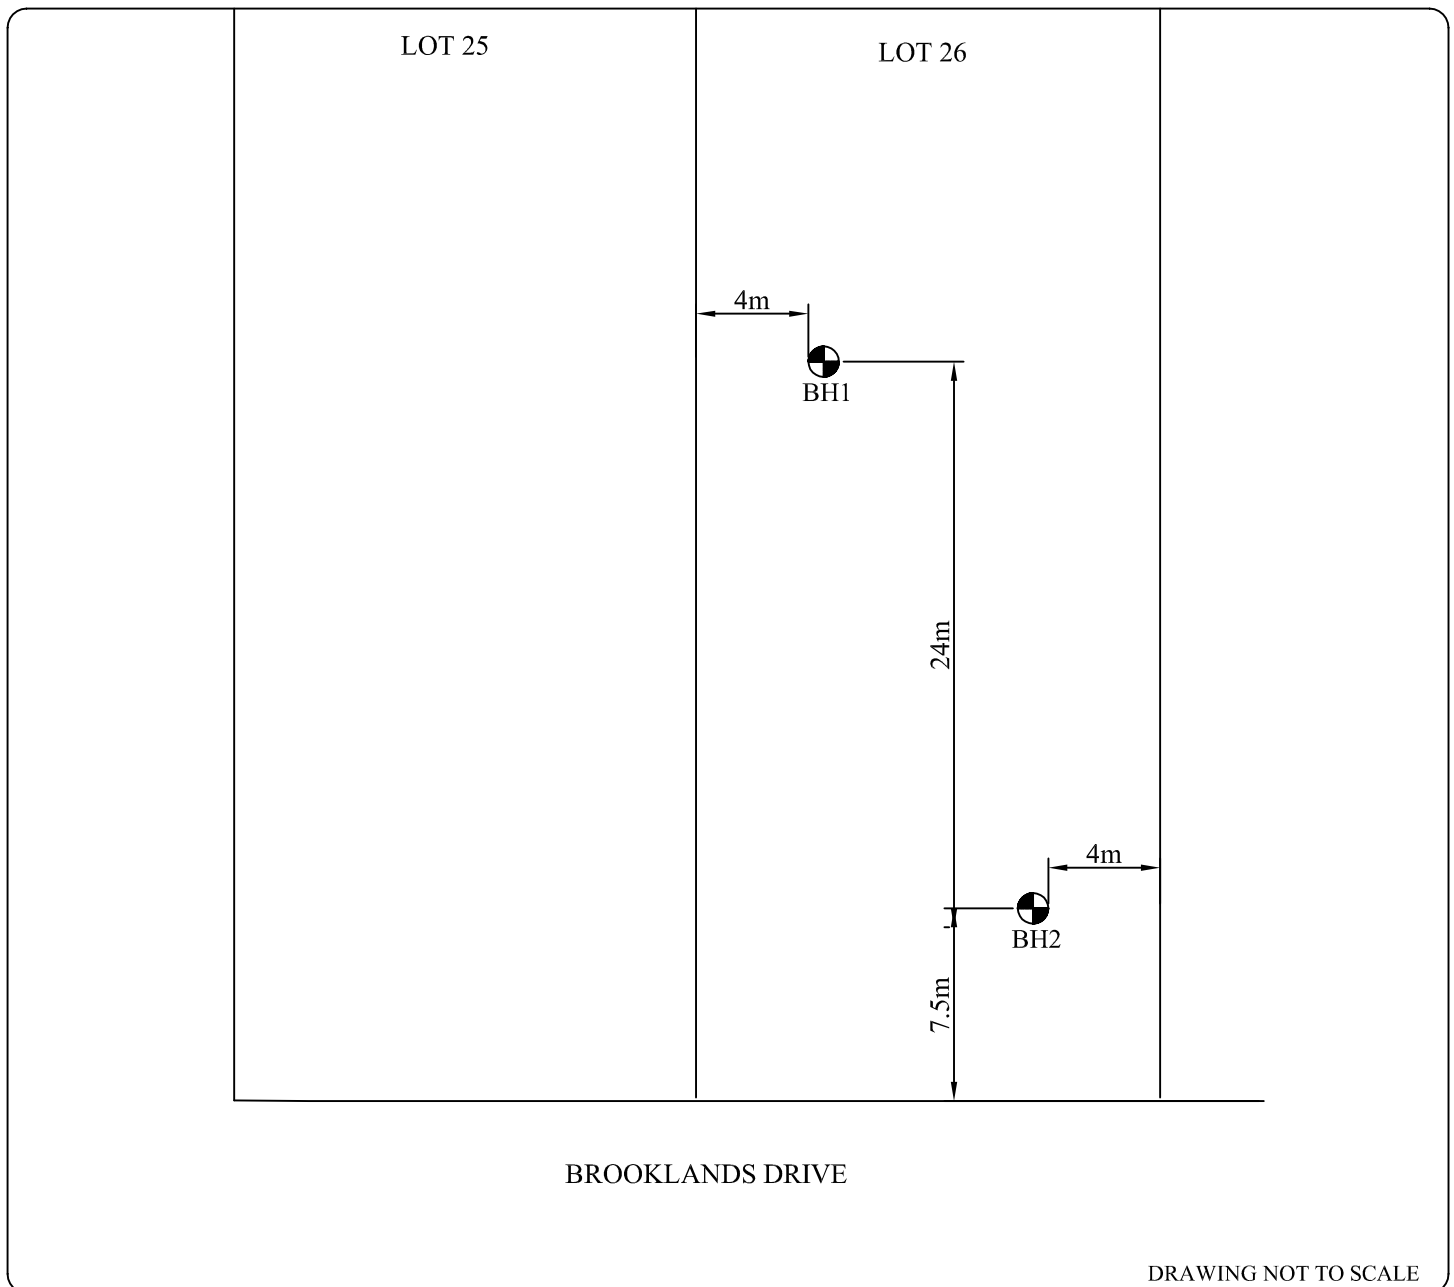
## Borehole Locations

Client :	ARBOR ESTATES
Project:	LOT 26 BROOKLANDS DRIVE CANTERBURY ESTATE

Borehole No. :	1 - 2
Report No. :	15C 0668
Date Drilled :	10/8/15
Operator:	ML
Drilling Method:	A.S
Page No.:	5 of 5

(T) = TREES

The investigation was conducted by a technician on the 10<sup>th</sup> August, 2015 using a vehicle mounted drill-rig and drilling 2 boreholes to depths of 1.5 metres within the designated area. The subsequent soil profiles are presented in page 4 and the location of the boreholes are presented on page 5.
