SITE CLASSIFICATION

Client: Arbor Estates
24 Jewell Court
East Bendigo, Vic 3550

Date: 20 August 2015

Project: Lot 37 Lancaster Drive, Canterbury Estate

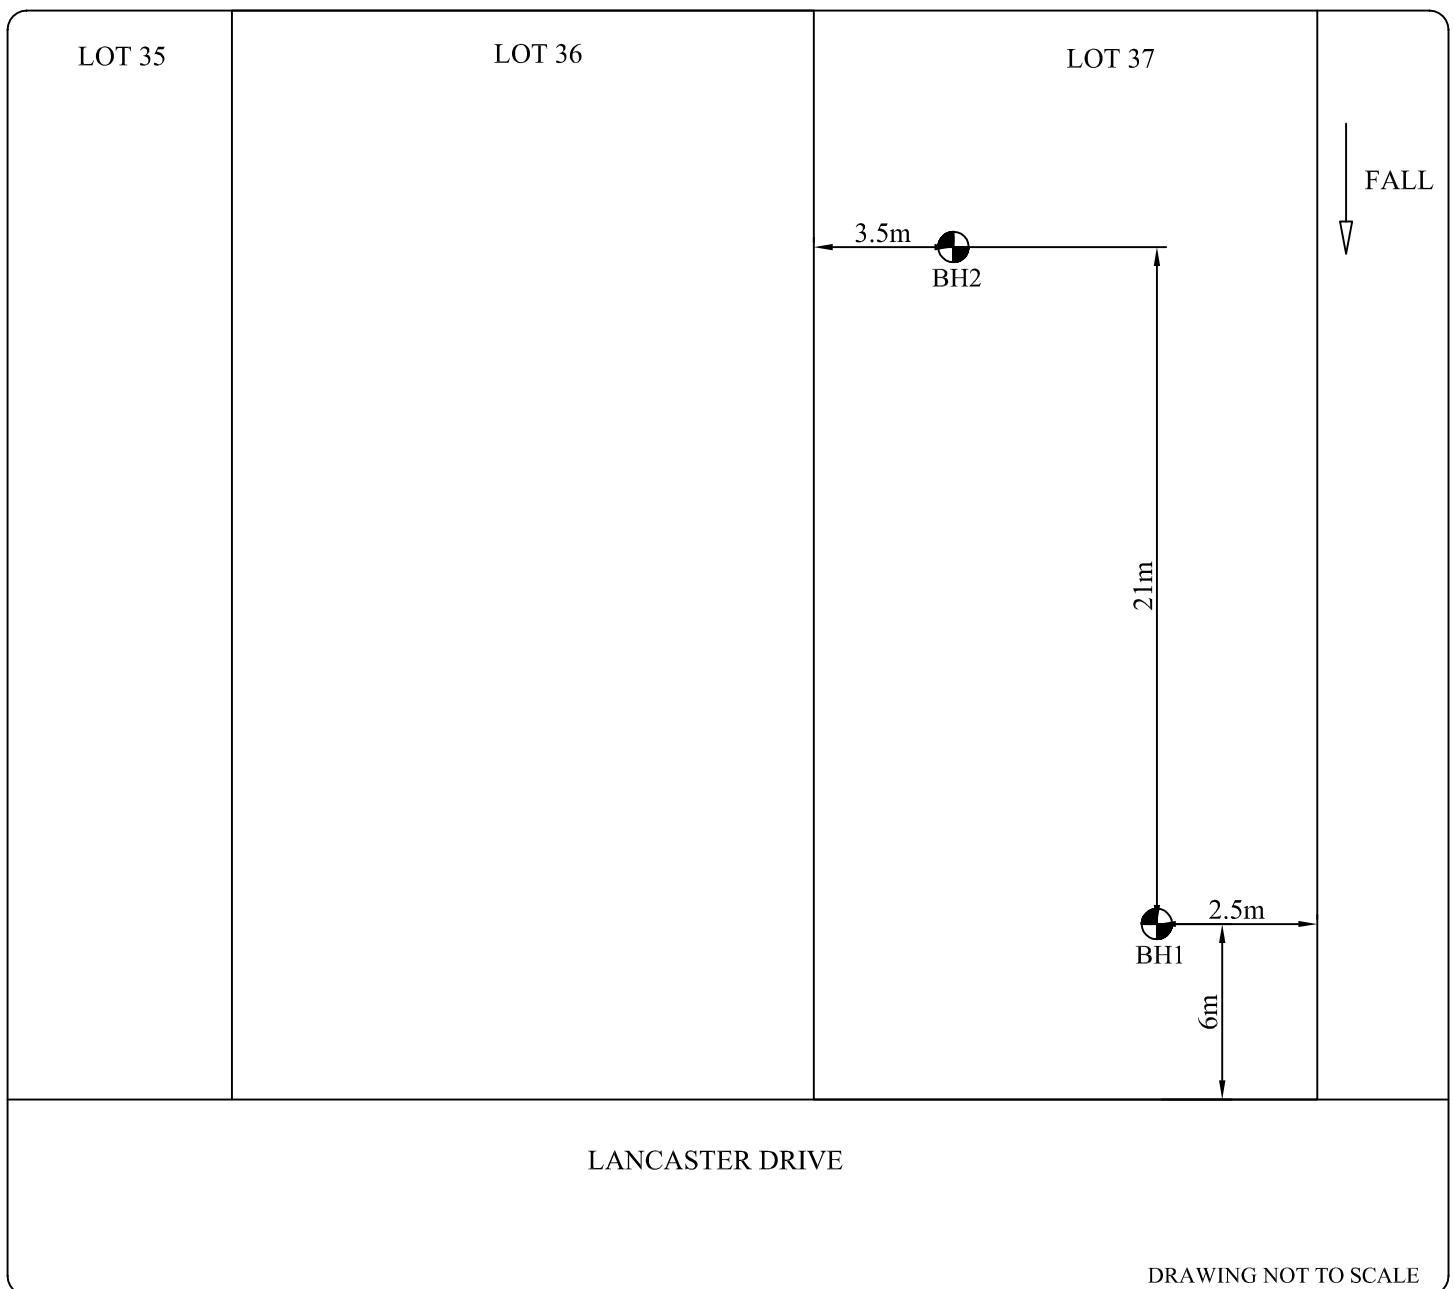
Borehole Locations

Client :	ARBOR ESTATES
Project:	LOT 37 LANCASTER DRIVE CANTERBURY ESTATE

Borehole No. :	1 - 2
Report No. :	15C 0668
Date Drilled :	13/8/15
Operator:	ML
Drilling Method:	A.S
Page No.:	5 of 5

The investigation was conducted by a technician on the 13th of August, 2015 using a vehicle mounted drill-rig and drilling 2 boreholes to depths of 1.5 to 3.0 metres within the designated area. The subsequent soil profiles are presented in page 4 and the location of the boreholes are presented on page 5.
