SITE CLASSIFICATION

Date: 23 December 2015

Project: Lot 42 Buxton Street, Canterbury Estate

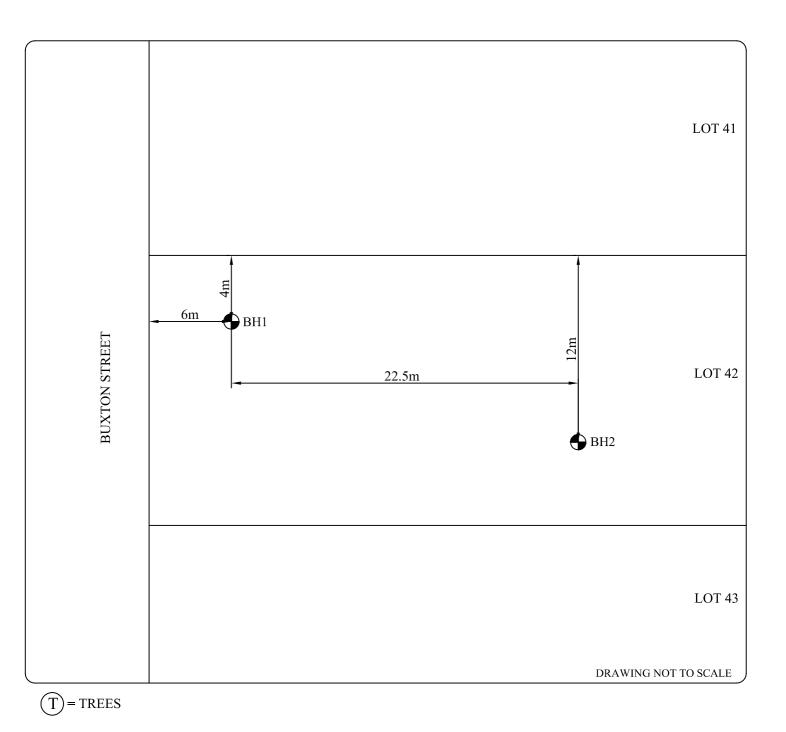
Borehole Locations

The investigation was conducted by a technician on the 9th of December, 2015 using a vehicle mounted drill-rig and drilling 2 boreholes to depths between 1.5 metres and 3 metres within the designated area. The subsequent soil profiles are presented in page 4 and the location of the boreholes are presented on page 5.
