GEOTECHNICAL
TESTING SERVICES
SOUTHERN

SITE CLASSIFICATION

Client: Arbor Estates Pty Ltd
24 Jewell Court
East Bendigo, Vic 3550

Project: Lot 69 Hudson Street, Canterbury Estate

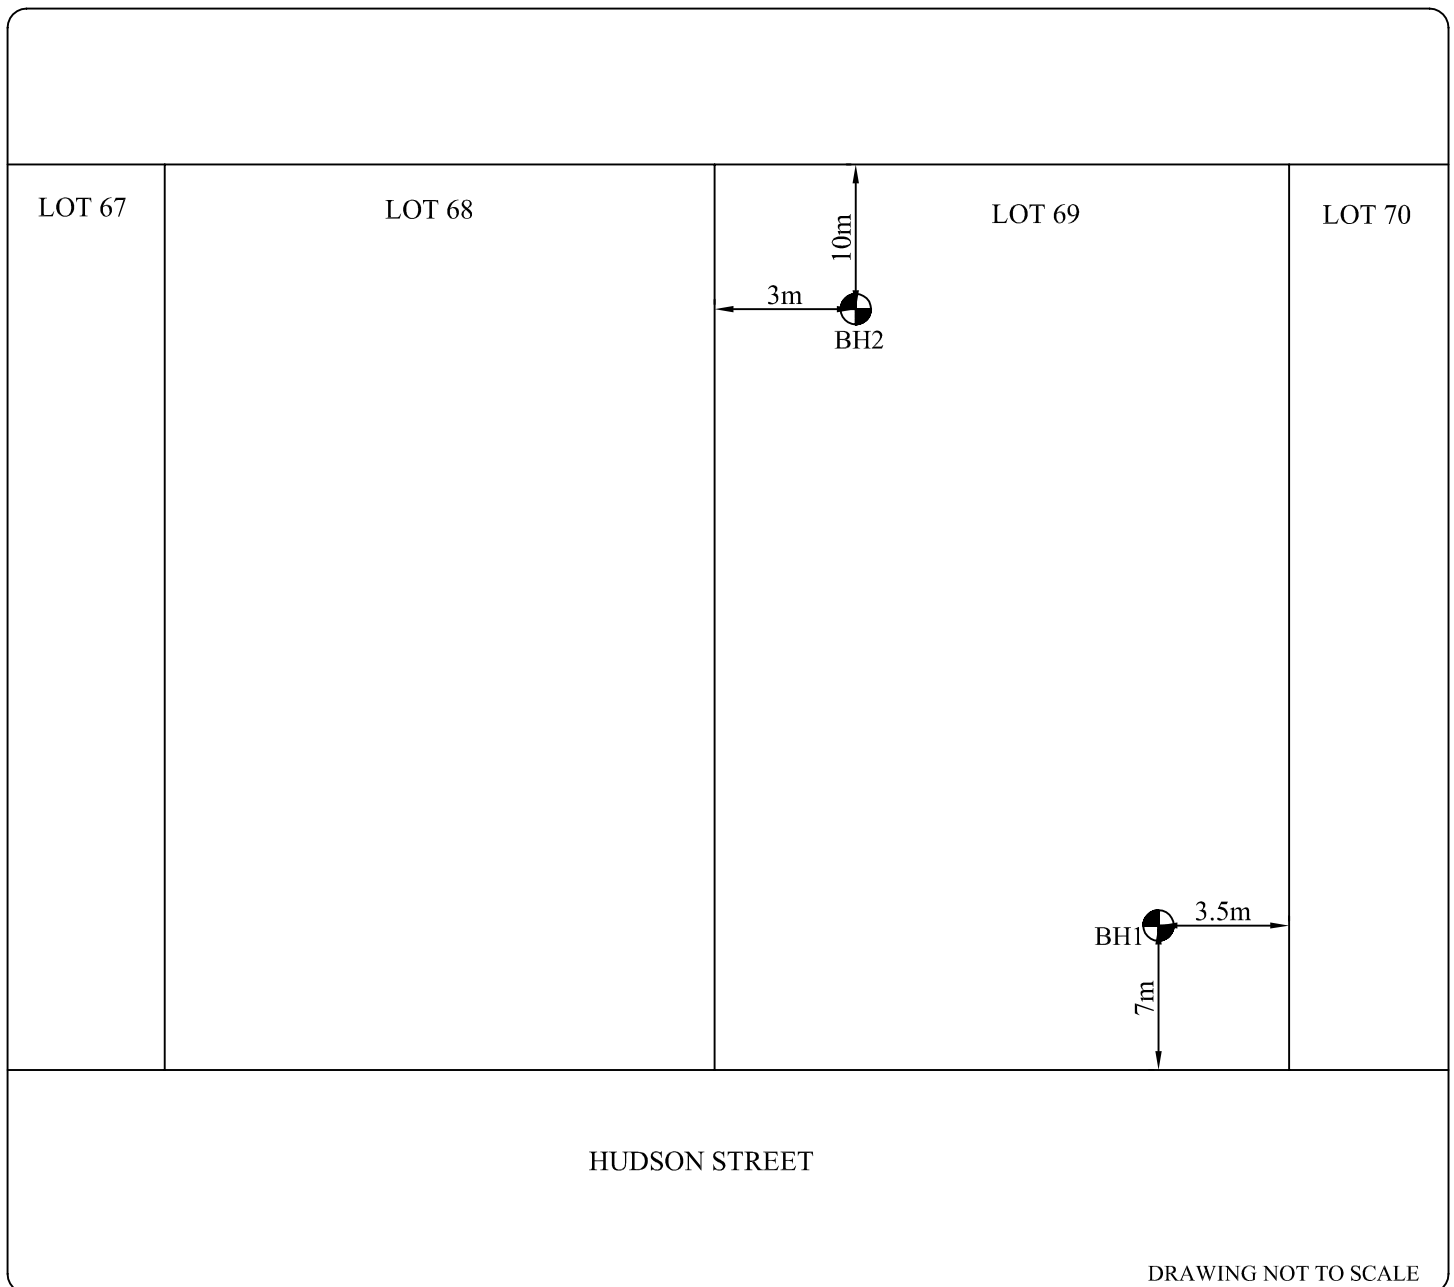
Borehole Locations

Borehole No. :	1 - 2
Report No. :	16C 0051
Date Drilled :	28/1/16
Operator:	ML
Drilling Method:	A.S
Page No.:	5 of 5

⊙ = TREES

The investigation was conducted by a technician on the 28th of January, 2016 using a vehicle mounted drill-rig and drilling 2 boreholes to depths of 1.5 to 3.0 metres within the designated area. The subsequent soil profiles are presented in page 4 and the location of the boreholes are presented on page 5.
