# SITE CLASSIFICATION

Date: 5 February 2016

Project: Lot 83 Hudson Street, Canterbury Estate

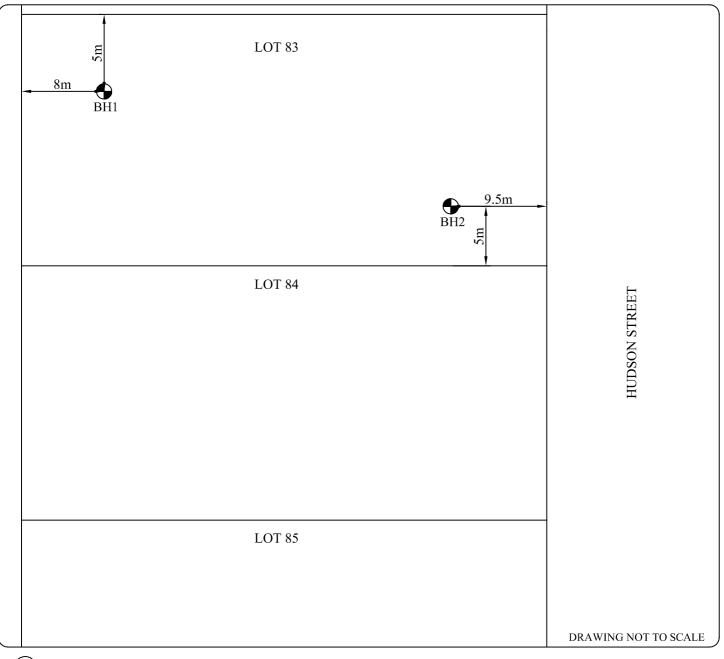
# Borehole Locations

Client :	ARBOR ESTATES PTY LTD		Borehole No. :	1 - 2
			Report No. :	16C 0051
			Date Drilled :	28/1/16
Project:	LOT 83 HUDSON STREET		Operator:	ML
, i i i i i i i i i i i i i i i i i i i	CANTERBURY ESTATE		Drilling Method:	A.S
			Page No.:	5 of 5

(T) = TREES
