# Lot 131 Canterbury Estate Stage 5 Jackass Flat

Site Classification for Arbor Estates

> Report 17C 0733 November, 2017

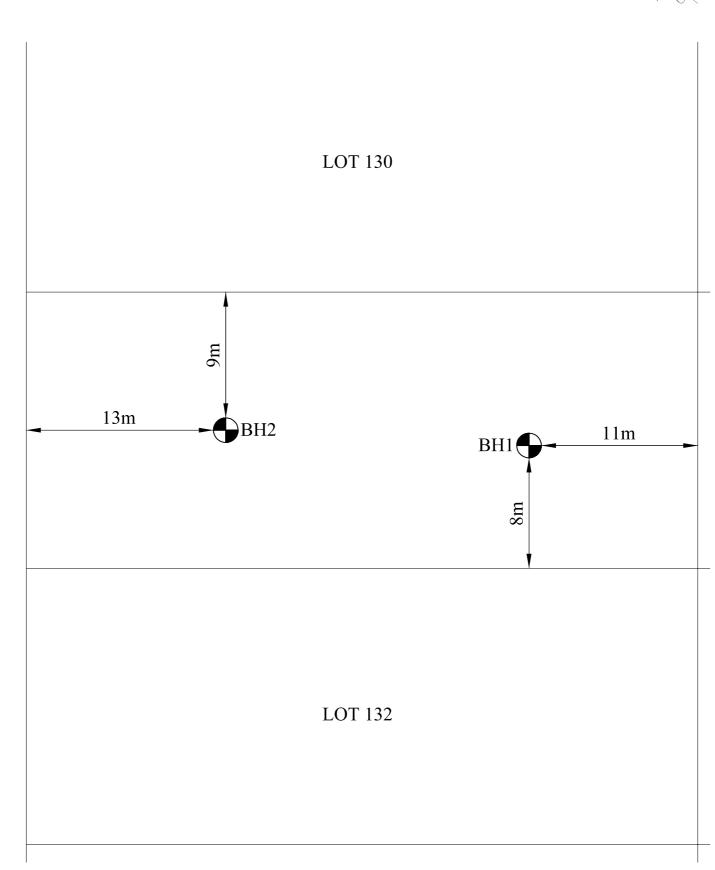
GEOTECHNICAL INVESTIGATION	<b>CLIENT:</b> ARBOR ESTATES <b>PROJECT:</b> LOT 131 CANTERBURY ESTATE STAGE 5, JACKASS FLAT		
APPROXIMATE LOCATIONS NOT TO SCALE	GTS REF: 17C 0733	DATE: 6 NOVEMBER 2017

The investigation was conducted by a technician on the 1<sup>st</sup> of November, 2017 using a vehicle mounted drill-rig and drilling 2 boreholes to depths of 1.5 to 3.0 metres within the designated area. The subsequent soil profiles are presented in page 6 and the location of the boreholes are presented on page 7.
