# Lot 142 – Discover Marong Stage 5 Marong

Geotechnical Investigation for Arbor Estates

> Report 19C 0356 (Lot 142) June 2019

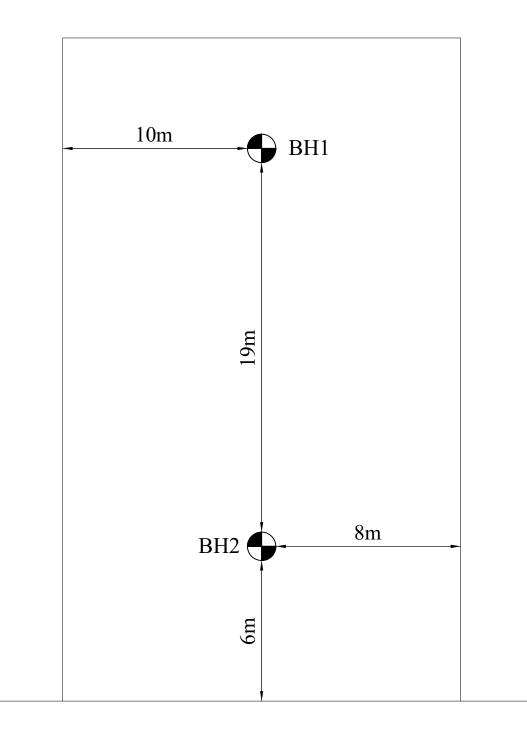
The investigation was conducted on the 23<sup>rd</sup> May 2019 using a trailer mounted drill-rig and drilling 2 boreholes to depths of 1.5 to 3.0 metres within the designated area. The subsequent soil profiles are presented on page 4 and the location of the boreholes is presented on page 5.
