# Lot 143 – Discover Marong Stage 5 Marong

Geotechnical Investigation for Arbor Estates

Report 19C 0356 (Lot 143) June 2019

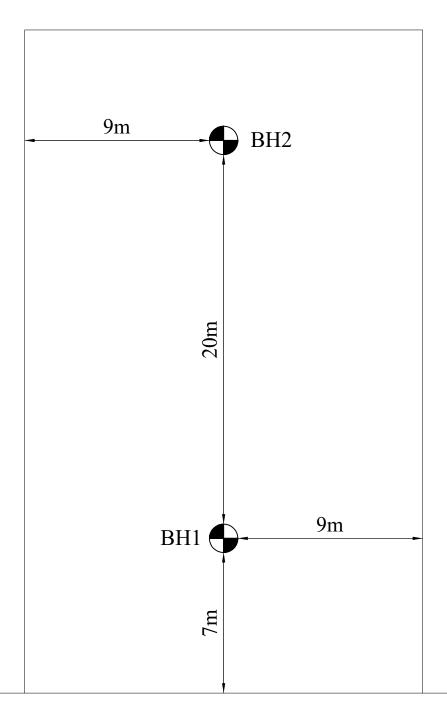
APPROXIMATE LOCATIONS NOT TO SCALE

The investigation was conducted on the 23<sup>rd</sup> May 2019 using a trailer mounted drill-rig and drilling 2 boreholes to depths of 1.5 to 3.0 metres within the designated area. The subsequent soil profiles are presented on page 4 and the location of the boreholes is presented on page 5.
