# Lot 184 – Discover Marong Stage 7 Marong

Geotechnical Investigation for Arbor Estates

Report 20C 0831 (Lot 184) October 2020

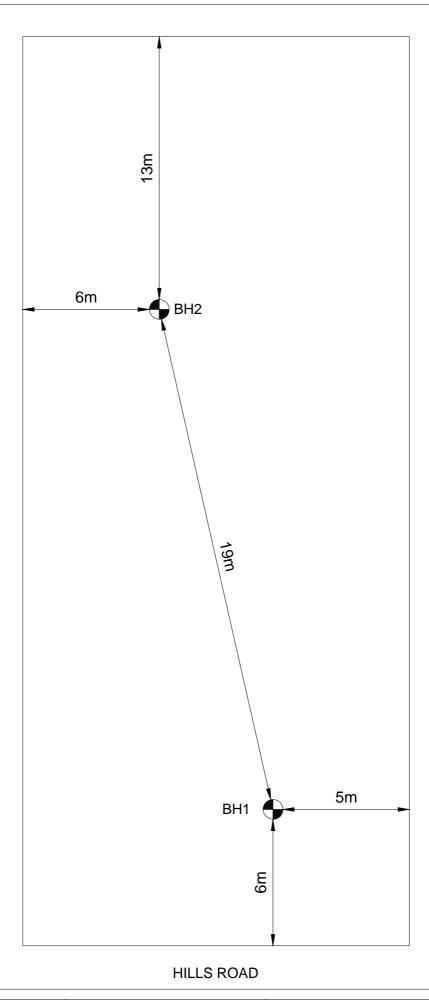
**GEOTECHNICAL INVESTIGATION**

The investigation was conducted on the 1<sup>st</sup> of October 2020 using a trailer mounted drill rig to drill 2 boreholes to depths of 1.5 to 3.0 metres within the designated area. The subsequent soil profiles are presented on pages 4 and the location of the boreholes is presented on page 5.

APPROXIMATE LOCATIONS NOT TO SCALE
