# Lot 13, Marong Run, Stage 7 Marong

Geotechnical Investigation for Arbor Estates

> Report 21C 1165 (Lot 13) December 2021

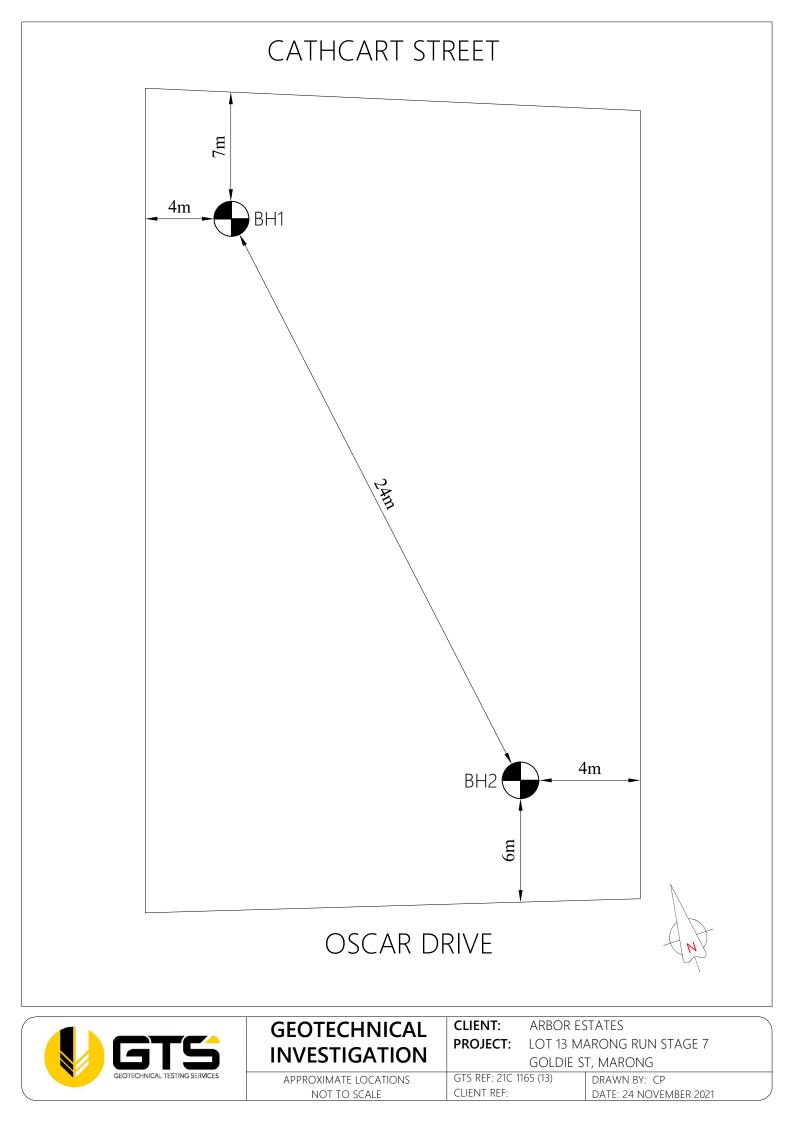
## **BOREHOLE LOGS**

nole log no:	1-2	
	Client:	Arbor Estates		Repo	ort number:	21C 1165 (Lot 13)	
				Dat	te drilled:	19/11/2021	
	Project:	Lot 13, Marong Run, Stage 7 Marong		Lo	gged by:	BT	
	FTOJECI.			Drillir	ng method:	AS	
Profile (mm):	* Structur (see key	Material Description:	Moisture Description:	Cohesion Density:	Plasticity:	Testing / Sampling:	
0		BH1					
То 200	FILL	Clayey Sandy SILT Brown, fine sand, trace fine gravel	D	L	Low		
То 400		Silty SAND Fine, pale brown	D – M	MD	-		
To 1200	Soil profi	e Silty CLAY Brown	D – M	VSt – H	High		
То 3000		Silty CLAY Pale brown, grey, trace fine to medium sand	D – M	VSt	Medium		
0		BH2					
То 400	FILL	Sandy Silty CLAY Brown, orange/brown, fine to medium sand	М	St	Medium – Iow		
То 600		Clayey SAND Fine to medium, pale brown	D – M	MD	Low		
		Brown, pale brown, fine to medium sand	М	St	Medium

Full details of the soil conditions are presented in the borehole logs.
