# Lot 215 Discover Marong Stage 8 Marong

## Geotechnical Investigation for Arbor Estates

Report 22C 0677 (Lot 215)  
October 2022

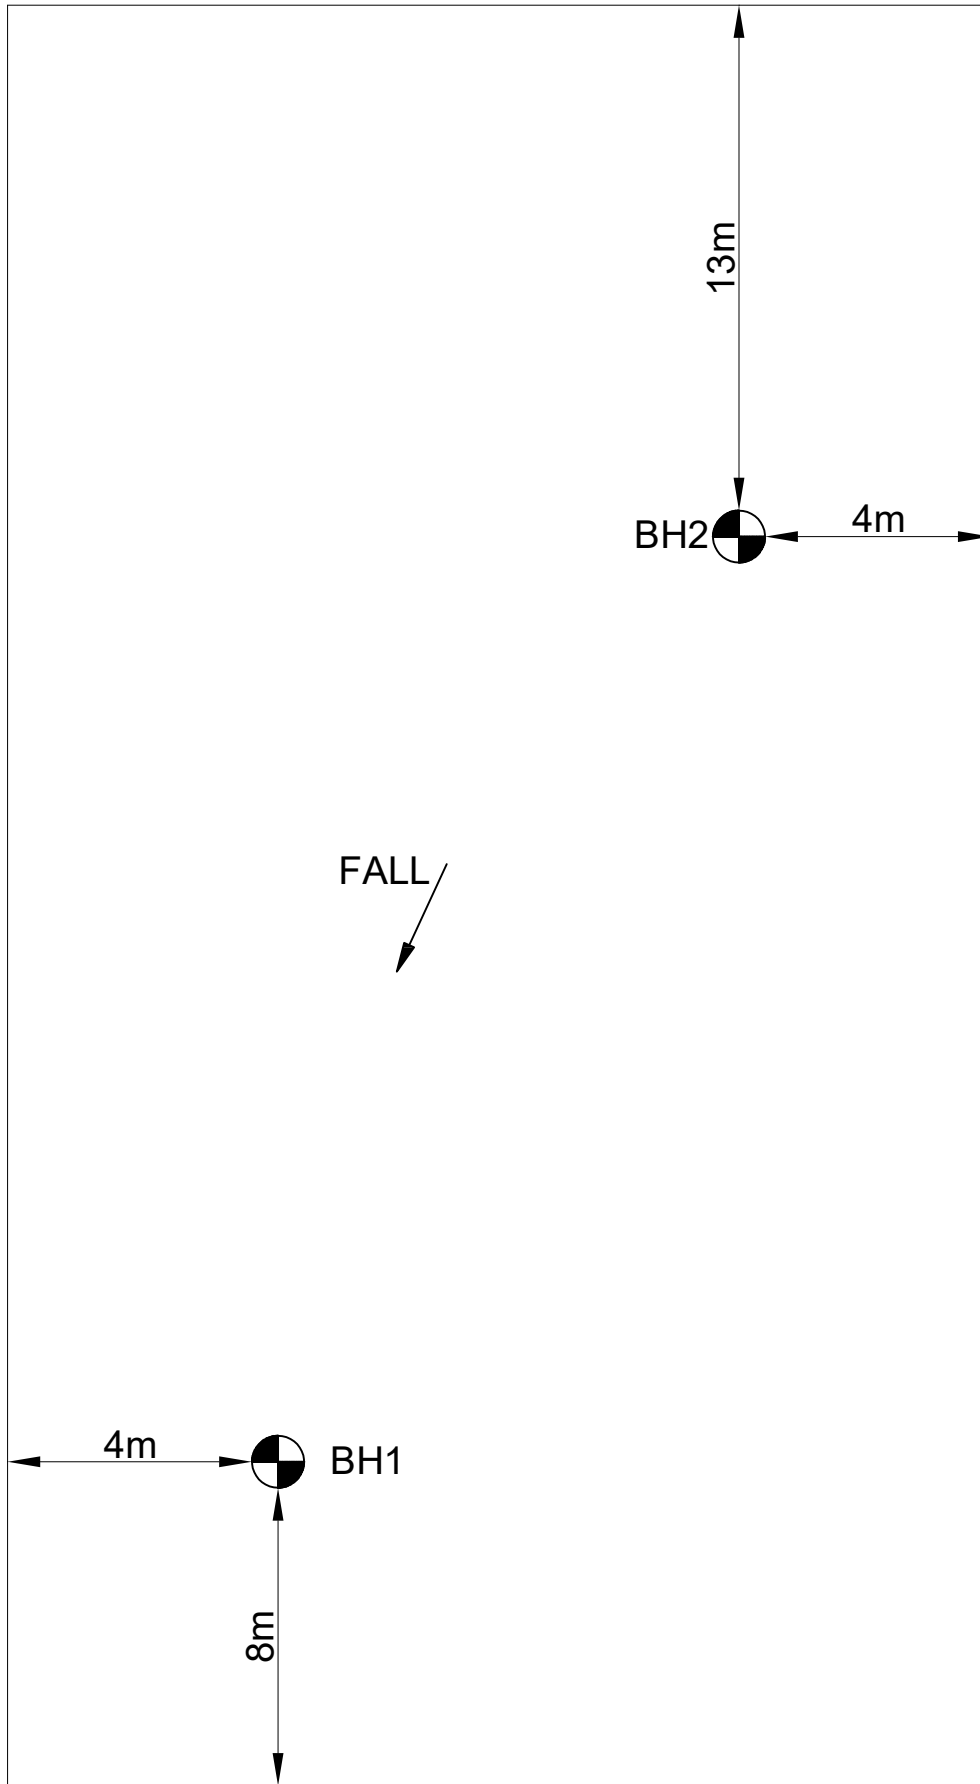
### GEOTECHNICAL INVESTIGATION

The investigation was conducted on the 20<sup>th</sup> of October 2022 using a vehicle mounted drill rig to drill 2 boreholes to depths of 3.0 metres within the designated area. The soil profiles and borehole locations are presented at the end of this report.

APPROXIMATE LOCATIONS  
NOT TO SCALE
