# Lot 221 Discover Marong Stage 8 Marong

Geotechnical Investigation for Arbor Estates

Report 22C 0677 (Lot 221) October 2022

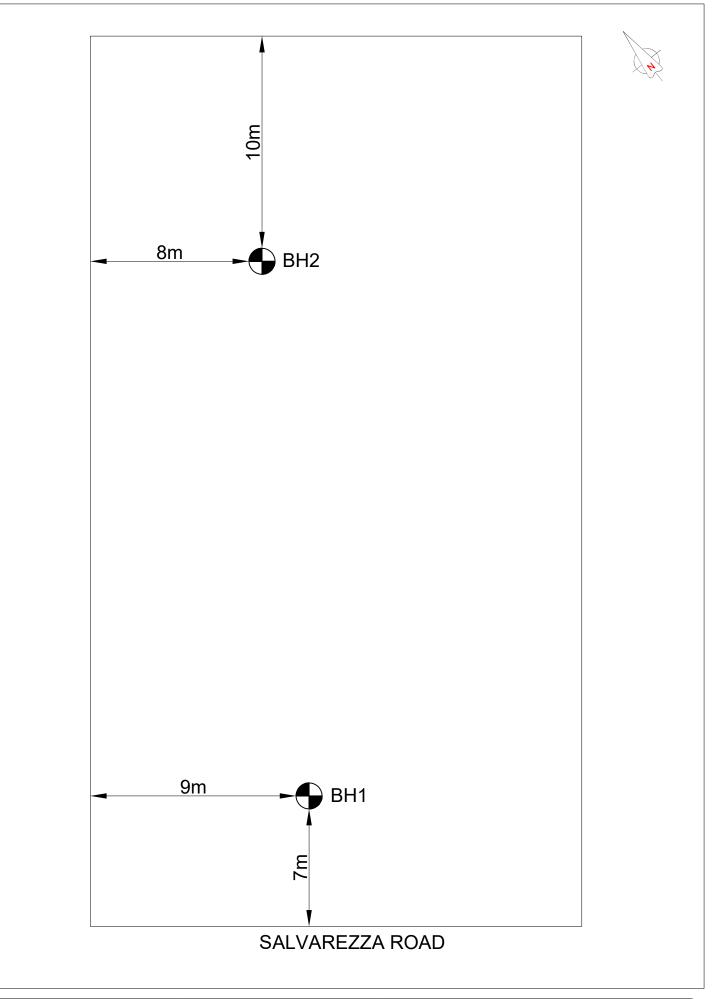
APPROXIMATE LOCATIONS

The investigation was conducted on the 20<sup>th</sup> of October 2022 using a vehicle mounted drill rig to drill 2 boreholes to depths of 3.0 metres within the designated area. The soil profiles and borehole locations are presented at the end of this report.

Silty CLAY, high plasticity, pale orange/brown, trace fine to coarse sand, trace fine gravel, trace fine to medium gravel limestone, stiff At depths below 0.2 metres in the region of BH1

• Silty CLAY, high plasticity, orange/brown, trace fine to medium sand, trace fine gravel, stiff At depths below 0.3 metres in the region of BH2
