# Lot 222 Discover Marong Stage 8 Marong

## Geotechnical Investigation for Arbor Estates

Report 22C 0677 (Lot 222)  
October 2022

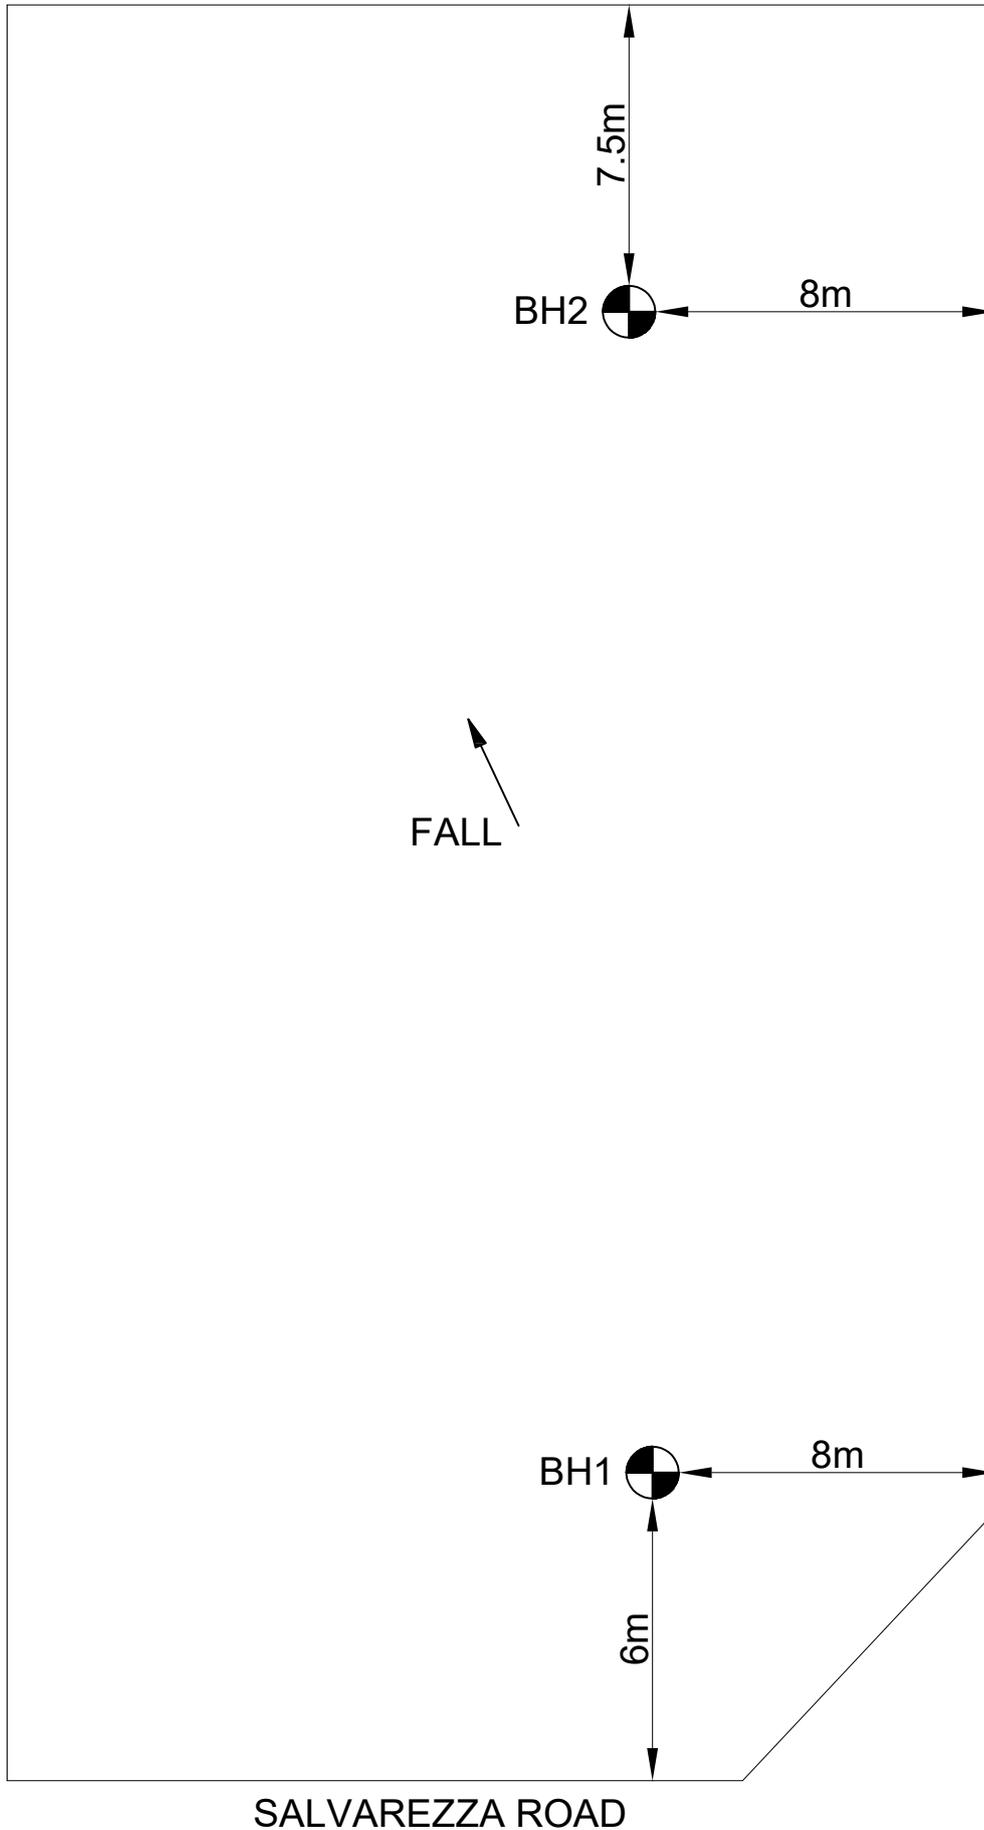
## GEOTECHNICAL INVESTIGATION

The investigation was conducted on the 20<sup>th</sup> of October 2022 using a vehicle mounted drill rig to drill 2 boreholes to depths of 3.0 metres within the designated area. The soil profiles and borehole locations are presented at the end of this report.

APPROXIMATE LOCATIONS  
NOT TO SCALE
