# Lot 225 Discover Marong Stage 8 Marong

## Geotechnical Investigation for Arbor Estates

Report 22C 0677 (Lot 225)  
October 2022

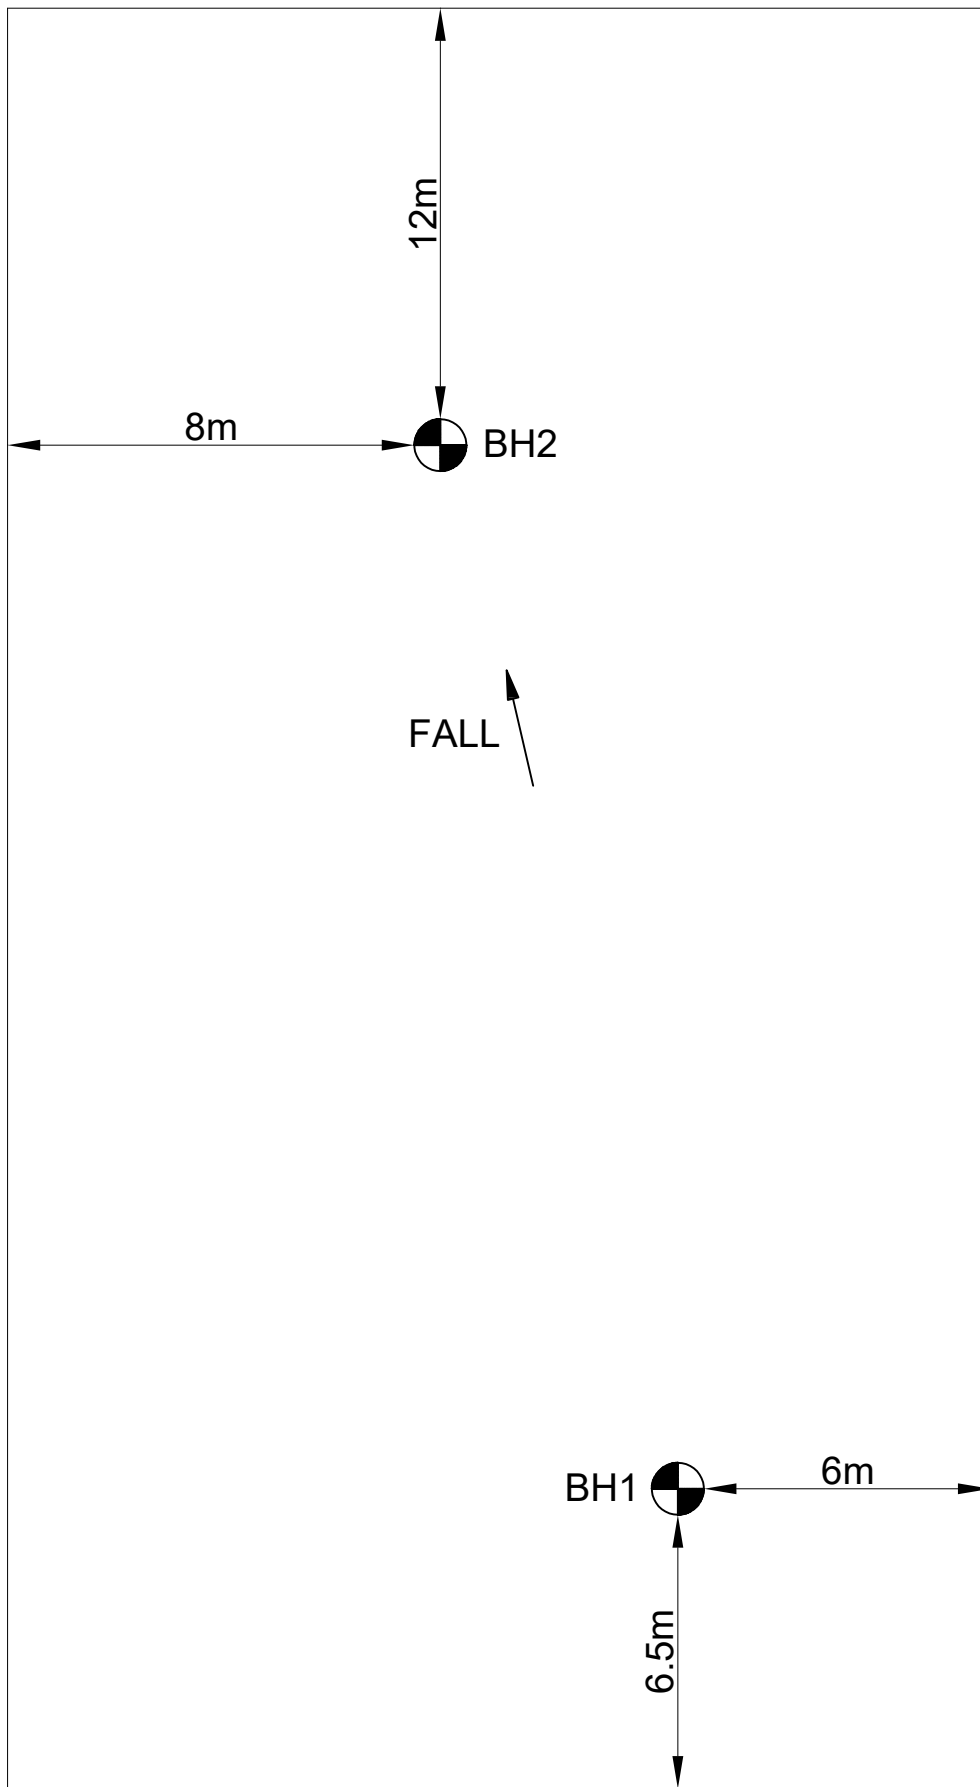
### GEOTECHNICAL INVESTIGATION

The investigation was conducted on the 20<sup>th</sup> of October 2022 using a vehicle mounted drill rig to drill 2 boreholes to depths of 3.0 metres within the designated area. The soil profiles and borehole locations are presented at the end of this report.

APPROXIMATE LOCATIONS  
NOT TO SCALE
