Lot 55 Marong Run Stage 9 Marong

Geotechnical Investigation for Arbor Estates

> Report 22C 0766 (Lot 55) November 2022

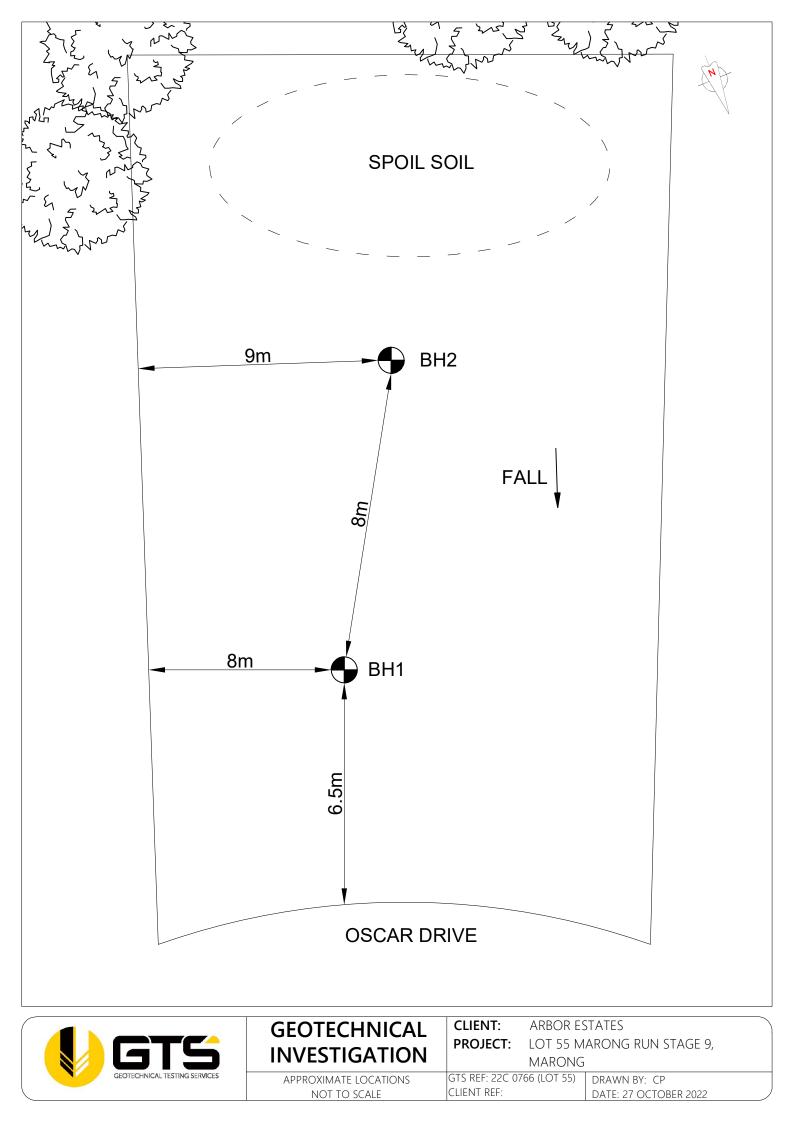
Borehole log no:	1-2
Client:	Arbor Estates	Report number:	22C 0766 (Lot 55)
		Date drilled:	20/10/22
Drojacti	Lot 55, Marong Run Stage 9	Logged by:	PB
Project:	Marong	Drilling method:	AS

Profile (mm):	* Structure: (see key)	Material Description:	Moisture Description:	Cohesion Density:	Plasticity:	Testing / Sampling:
0		BH1				
To 250	Controlled FILL	Silty CLAY Brown, trace fine to medium sand	М	S	Medium	-
To 1500	Soil Profile	Sandy CLAY Pale orange/brown, fine sand	D	St	Medium	-
To 3000	Soli Piolile	Sandy CLAY Pale brown, fine sand	D	St	Medium	-
0		BH2				
To 200	Controlled FILL	Silty CLAY Brown, trace fine to medium sand	М	S	Medium	-
To 1000	Soil Profile	Sandy CLAY Pale orange/brown, fine sand	D	St	Medium	-
To 3000	Son Prome	Sandy CLAY Pale brown, fine sand	D	St	Medium	-

• Sandy CLAY, medium plasticity, pale orange/brown, fine sand, stiff At depths below 0.2 metres in the region of BH2, and at depths below 0.25 metres in the region of BH1.
