# Lot 1 Bartels Run Stage 1 Jackass Flat

Geotechnical Investigation for Arbor Estates

Report 24C 0185-1 April 2024

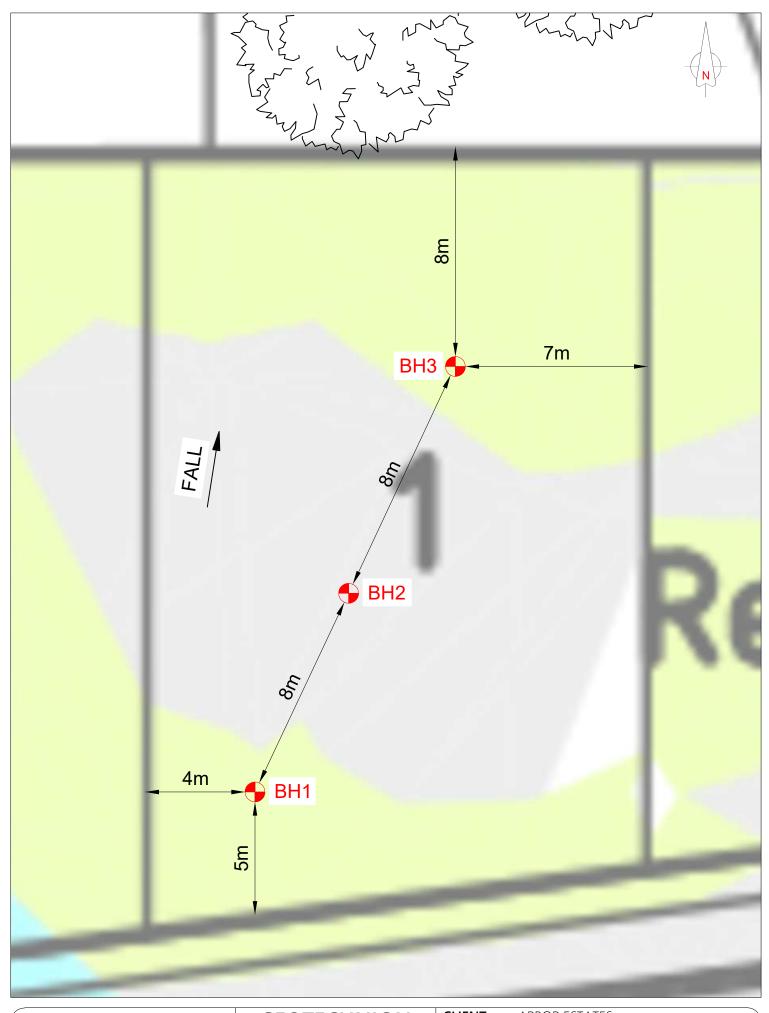
# GEOTECHNICAL INVESTIGATION

The investigation was conducted on the 9<sup>th</sup> of April 2024 using a vehicle mounted drill rig to drill 3 boreholes to depths of 1.8 to 2.0 metres within the designated area. The soil profiles and borehole locations are presented at the end of this report.

APPROXIMATE LOCATIONS NOT TO SCALE **CLIENT:** ARBOR ESTATES
