Lot 19 Bartels Run Stage 1 Jackass Flat

Geotechnical Investigation for Arbor Estates

> Report 24C 0185-19 April 2024

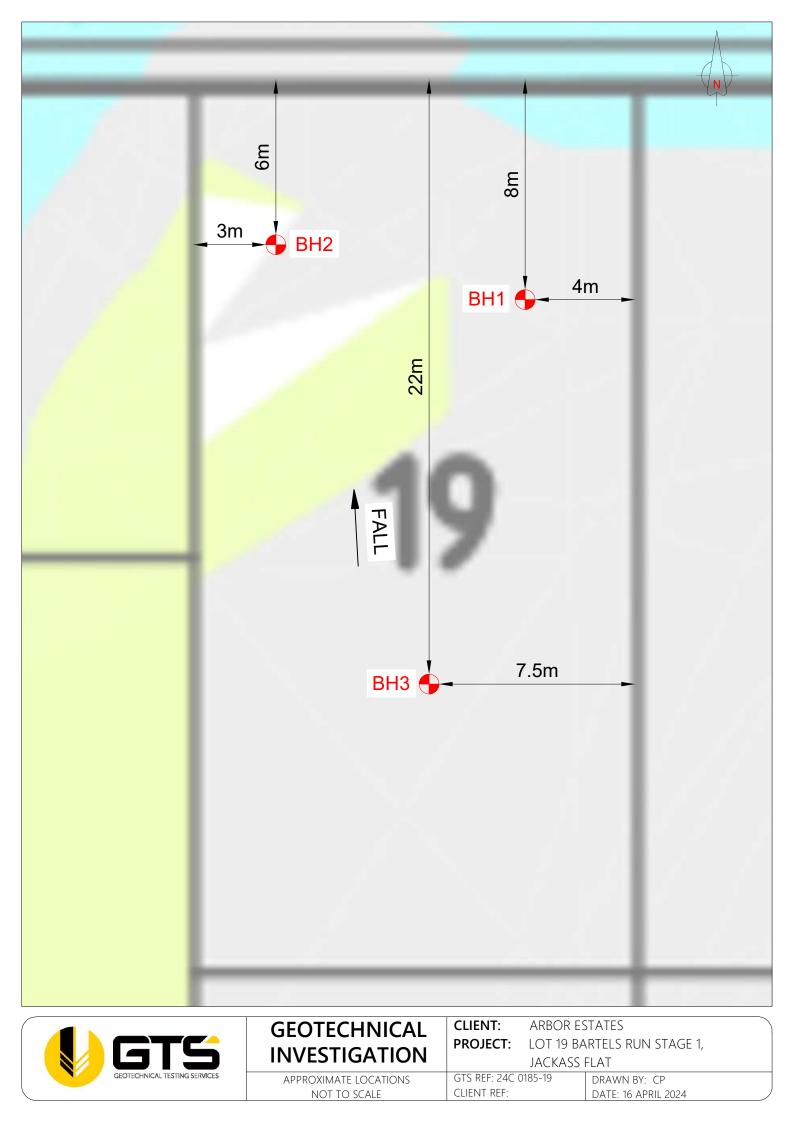
The investigation was conducted on the 12th of April 2024 using a trailer mounted drill rig to drill 3 boreholes to depths of 1.5 metres within the designated area. The soil profiles and borehole locations are presented at the end of this report.
