Lot 2 Bartels Run Stage 1 Jackass Flat

Geotechnical Investigation for
Arbor Estates

Report 24C 0185-2
April 2024

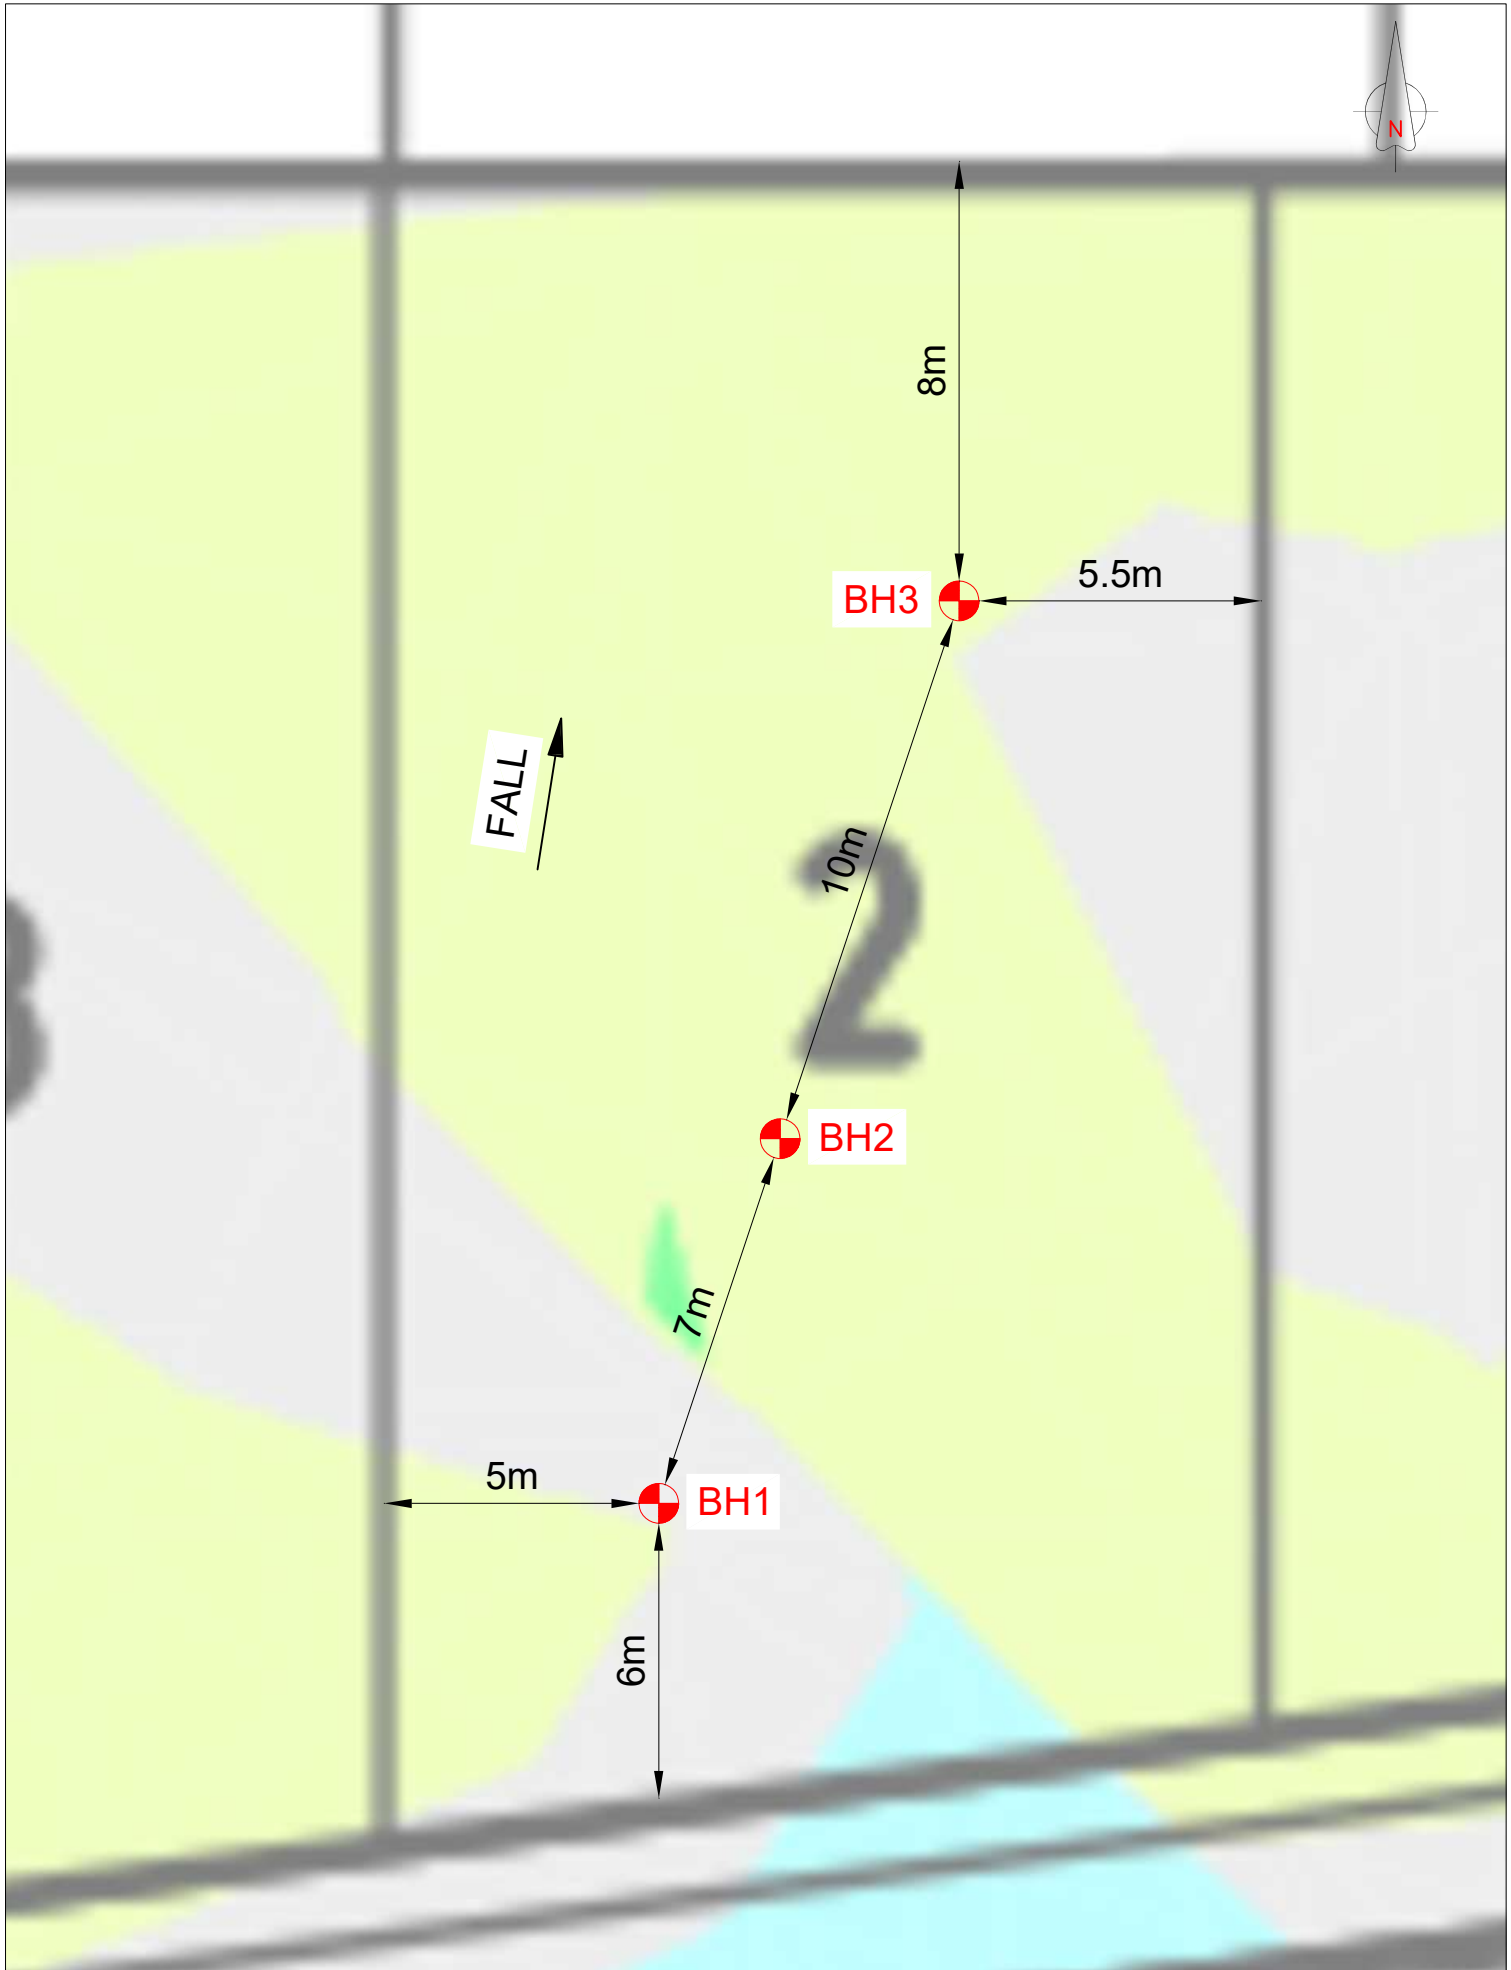
The investigation was conducted on the 9th of April 2024 using a vehicle mounted drill rig to drill 3 boreholes to depths of 2.1 to 2.4 metres within the designated area. The soil profiles and borehole locations are presented at the end of this report.
