# Bartels Run Stage 2 – Lot 36 Jackass Flat

Geotechnical Investigation for  
Arbor Estate

Report 25C 0327 Lot 36  
May 2025

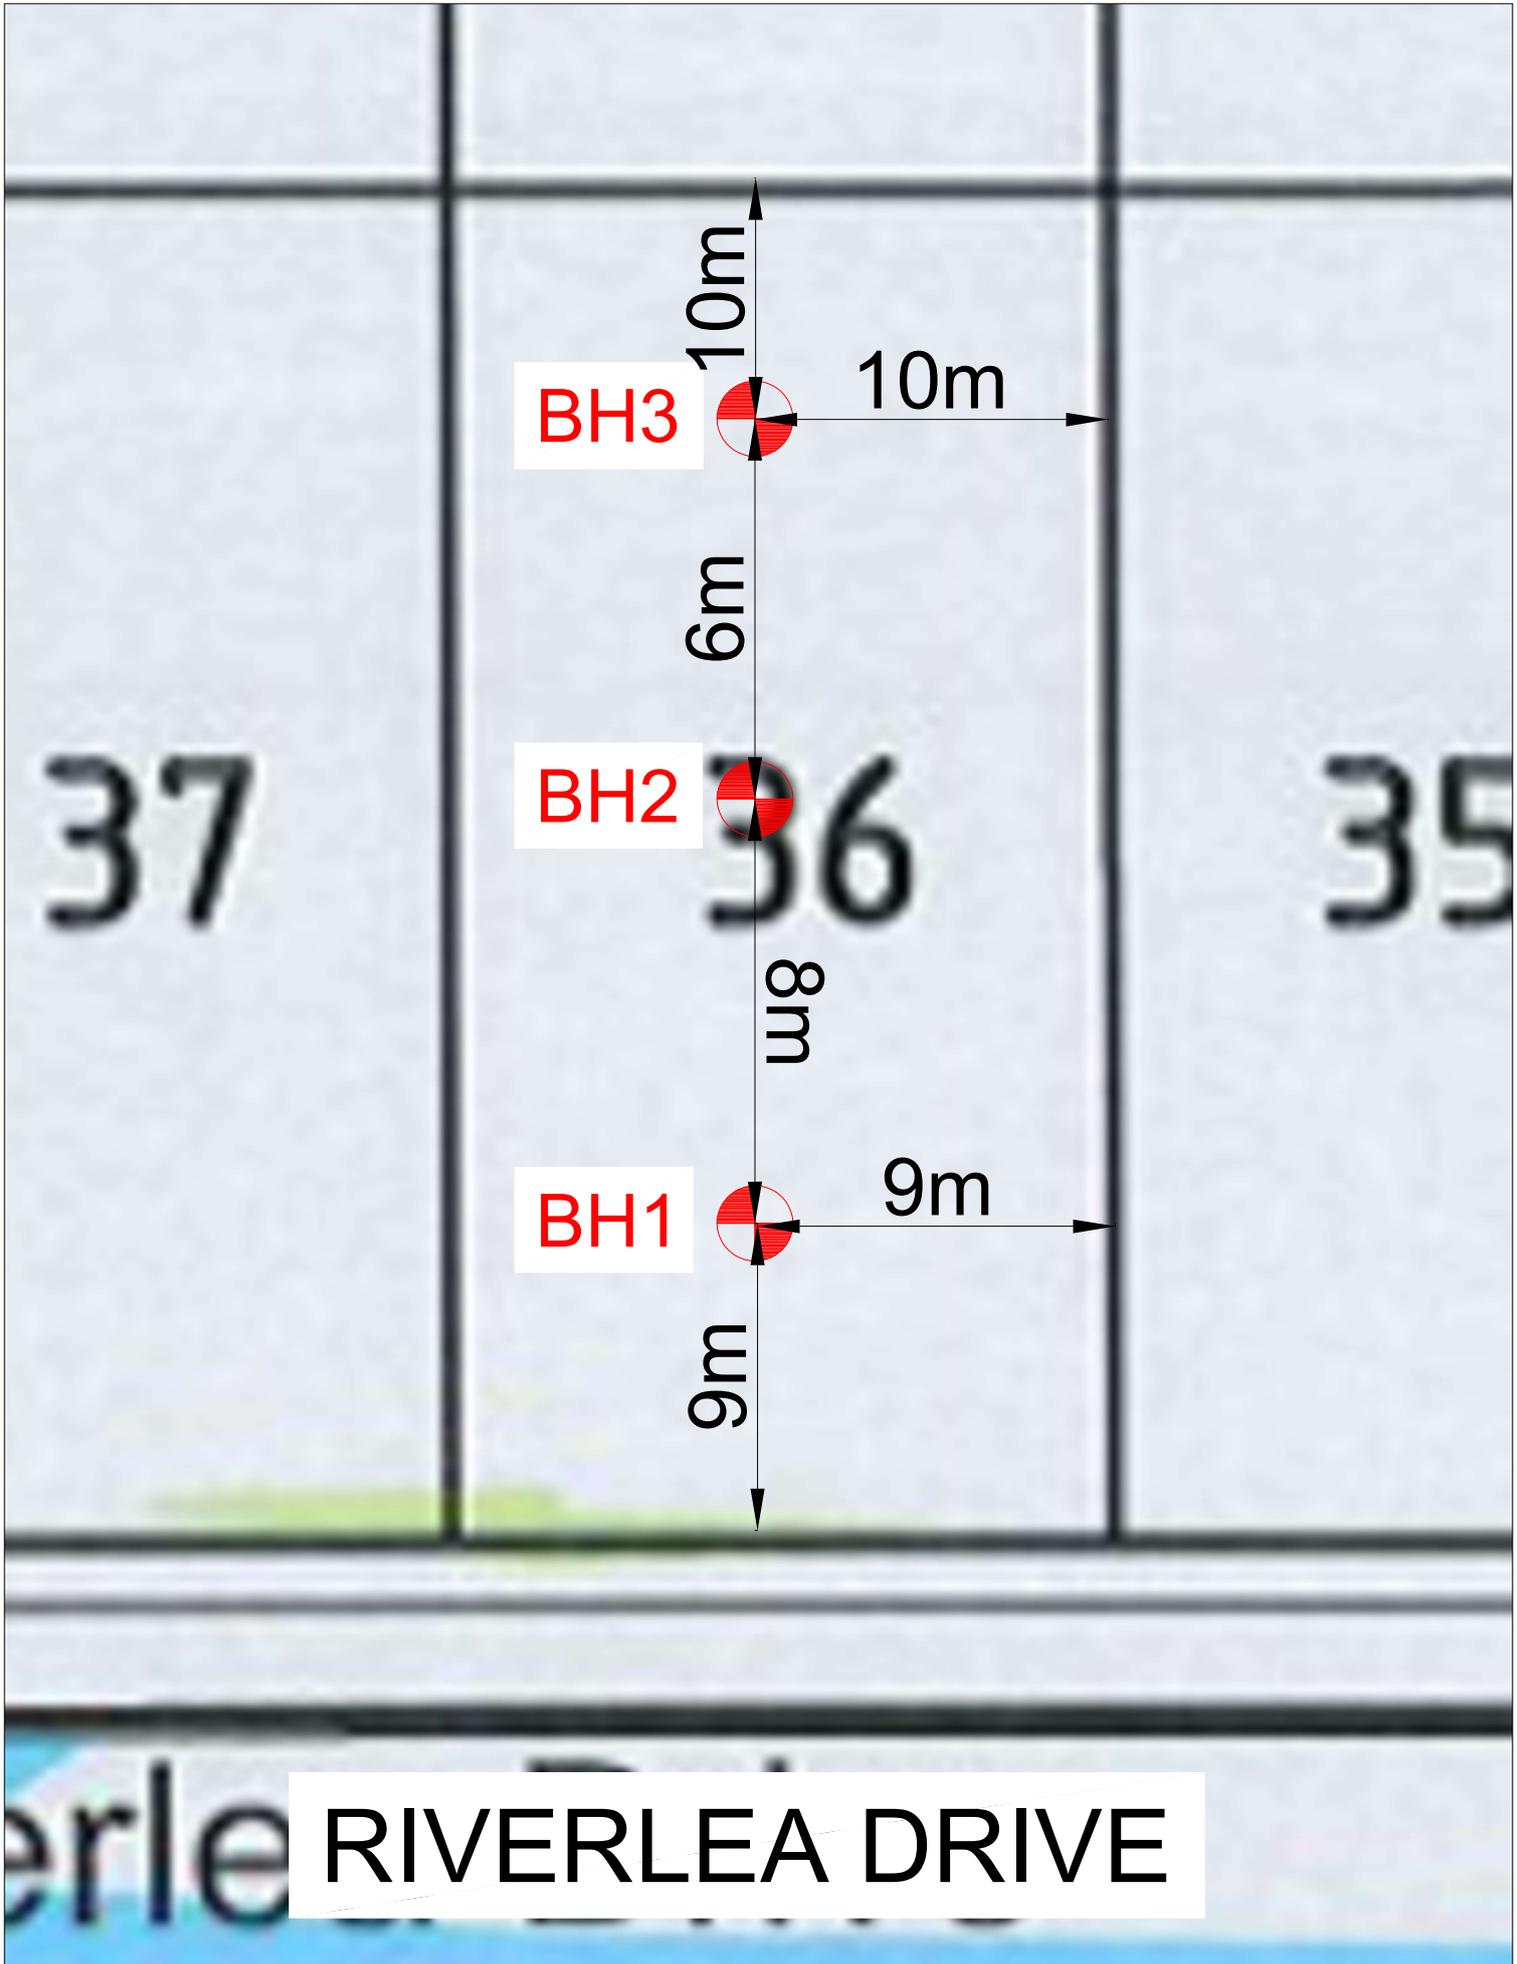
# RIVERLEA DRIVE

<b>GTS</b> <small>GEOTECHNICAL TESTING SERVICES</small>	<b>GEOTECHNICAL INVESTIGATION</b>		<b>CLIENT:</b> ARBOR ESTATES <b>PROJECT:</b> BARTELS RUN STAGE 2 LOT 36
	APPROXIMATE LOCATIONS NOT TO SCALE		GTS REF: 25C 0327 CLIENT REF:
			DRAWN BY: CC DATE: 8 MAY 2025

The investigation was conducted on the 29<sup>th</sup> of April 2025 using a vehicle mounted drill rig to drill 3 boreholes to depths of 2.3 to 3.0 metres within the designated area. The soil profiles and borehole locations are presented at the end of this report.
